Manhole Inspection Summary

Manhole # S45S__002MH

Location Address: **1109 haubert st**

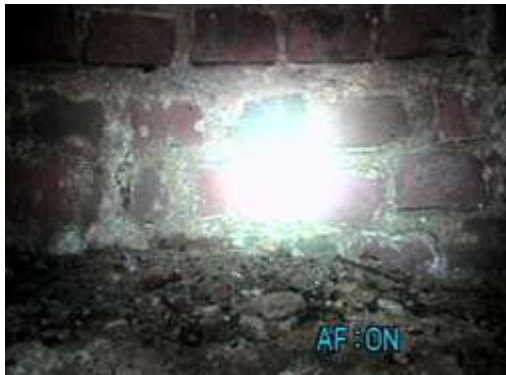
Defect 2

Condition: ☐ Sound ☐ Cracked ☐ Root Intrusion ☐ Deteriorated ☐ Leaks ☒ **Debris**

bench debris

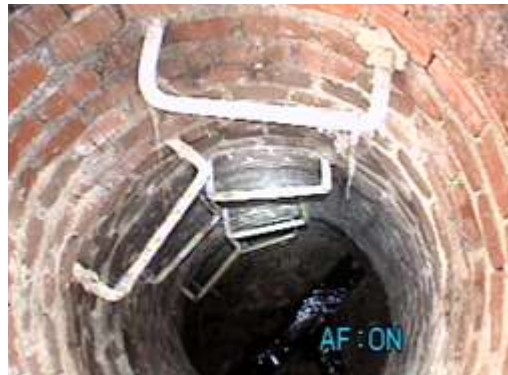
Defect 1

Count: **10** Missing: **0** ☒ **Corroded**

steps corroded

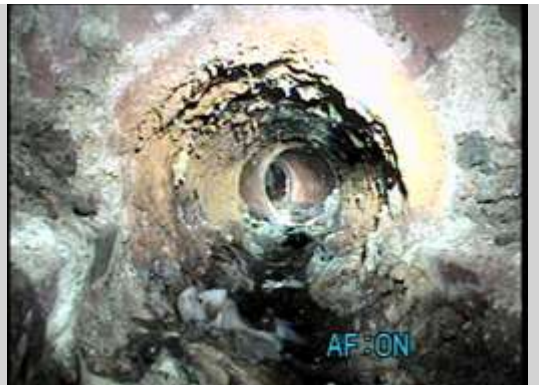
4 O'Clock Inflow

pipe interior looks deteriorated
